Mersin Photogrammetry Journal

3D study of modelling and animation of Kayseri Gülük Mosque

In this study, the Mosque of Güllük documentation work is made with the close-range photogrammetric method. Detailed stone drawings were made on the exterior of the Güllük Mosque. In addition, a 3D model of the building was obtained and this model was presented as an animation on the virtual platform.

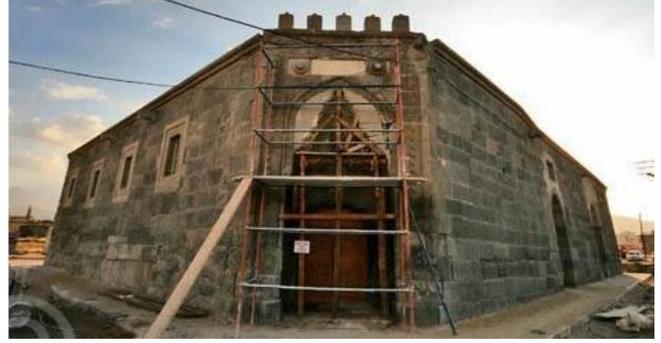
Figure 2. Güllük Mosque

and four feet of different apertures in the east and west directions, and the top is covered with a double-centered cradle vault as in the entrance section. 3.80x5.80 m in the middle of this vault. It has a rectangular opening. It was determined that there was an opening (skylight) in the middle of the mosque, which was first seen in Seljuk architecture. This opening was later converted into squares with additional arches to the east and west directions, and 3.60 m. The image of the restoration works of the building is shown in figure 2.

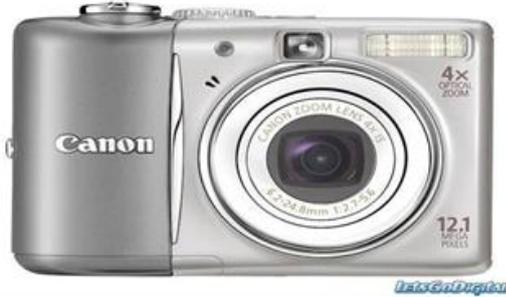
Figure 3. Canon IXUS 180

In the field study, the photos of the object to be documented are taken first. Photos of the historical building were taken with a Canon digital handheld camera. The digital handheld camera is shown in Figure 3. Technical features are shown in table 1.

Table 1. Canon IXUS 180 Technique Specifications (URL-3)

Canon IXUS 180	
Effective megapixels	20
Total megapixels	20.5
Sensor size size	1/2.3"
Max. image resolution	5152 x 3864
Crop factor/Optical zoom	5.62 / 10x
ISO	Auto, 100-1600
Focal length	24 - 240 mm
Max aperture	f3 - f6.9
Max. aperture	f16.9 - f38.8
Min. shutter speed	15 sec
Max. shutter speed	1/2000 sec
White balance presets	5
Screen size / resolution	2.7" / 230,400 dots
Max. video resolution	1280x720 (25p)
Weight	138 g
Dimensions	95.3 x 56.8 x 23.6 mm

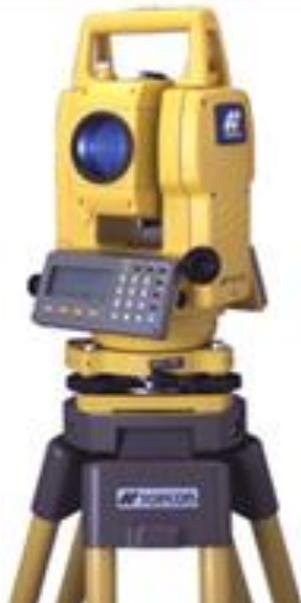
Figure 4. Topcon 3007 Totalstation

Measurements should be made with at least three detail points in each image (Burns et al., 2009). The number of detail points varies depending on the size of the surface. In the study, 32 detail measurements were made. Measurements were made with the Topcon GPT-3007 geodetic instrument shown in Figure 4.

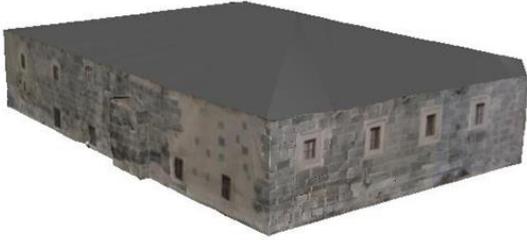
Figure 8. Textured model of Güllük Mosque

Finally, the real model and the surface were applied to the 3D model created as the basic structure (Figures 8 and 9). Then, the 3D model obtained was transferred to Sketchup software and the missing facades were completed (Figure 9).
